historic structure report  
architectural data section

# HOPEWELL VILLAGE

## THE IRONMASTER'S HOUSE

THE IRONMASTER'S HOUSE  
HOPEWELL VILLAGE NATIONAL HISTORIC SITE  
HOPEWELL, PENNSYLVANIA

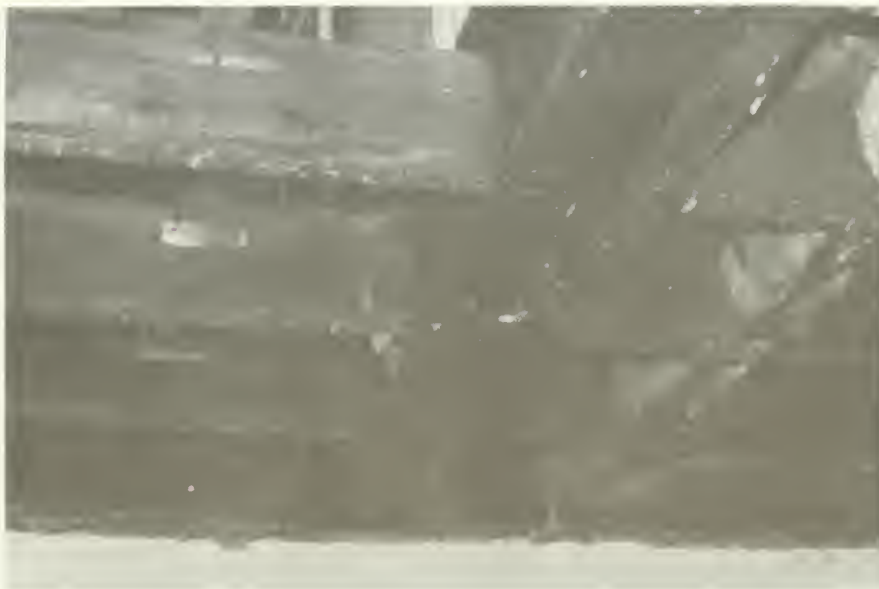
8. Room 101: southwest parlor. Existing ceiling summer beam and framing exposed at north wall over Doorway 102. Existing tension rod plate on underside of summer beam, December 13, 1979.

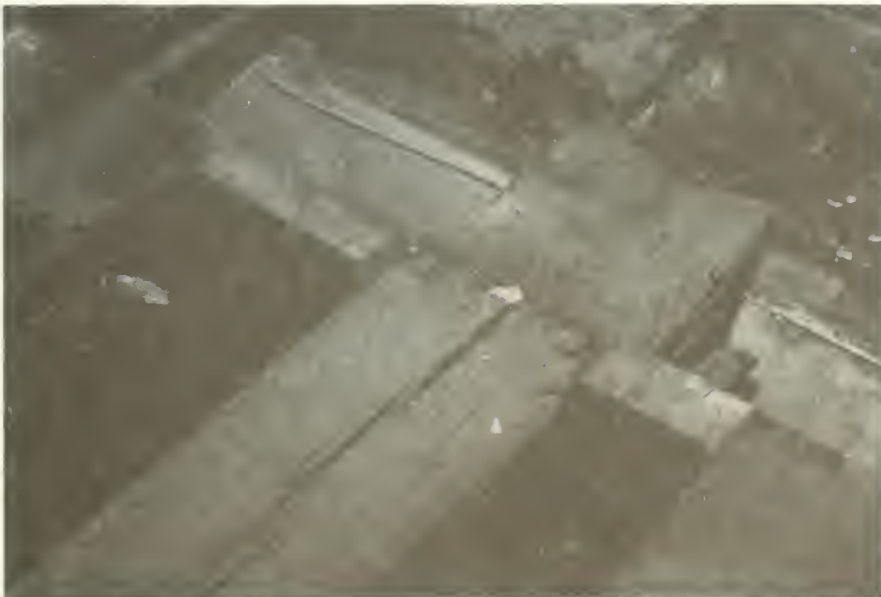
21. Room 104: east wing dining room. Charred end of existing floor summer beam at east wall fireplace pocket. Joists mortised and pegged into summer beam, December 13, 1979 (refer to photograph 3).

5. The temporary post in Room 004 was removed. The burnt end of the summer beam under the firebox of the fireplace in Room 104 was removed. The summer beam end was supported on two steel angles which extended into the beam pocket of the stone wall. Wood 2-by blocking was bolted into the steel angles to relieve wood floor joists.

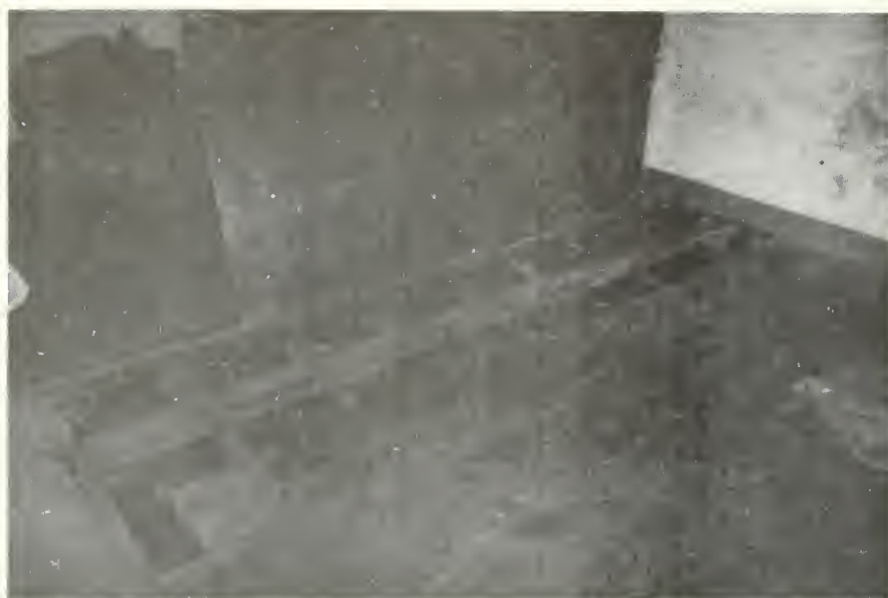
24. Room 104: east wing dining room.  
View towards west wall of existing  
ceiling summer beam and joists.  
Blocking between joists for what  
was possibly at one time a forced  
air floor grill, December 13, 1979.

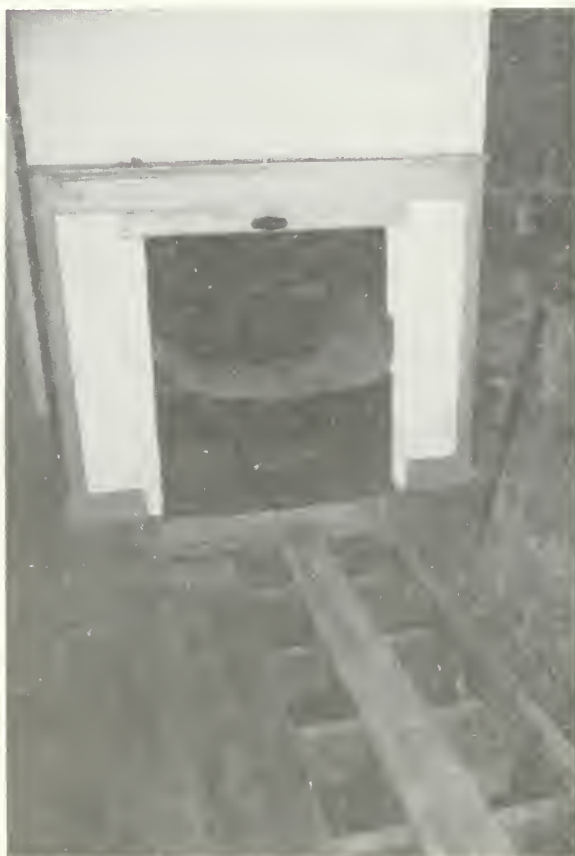
25. Room 105: east wing kitchen. Existing floor framing - summer beam and joists, December 13, 1979.

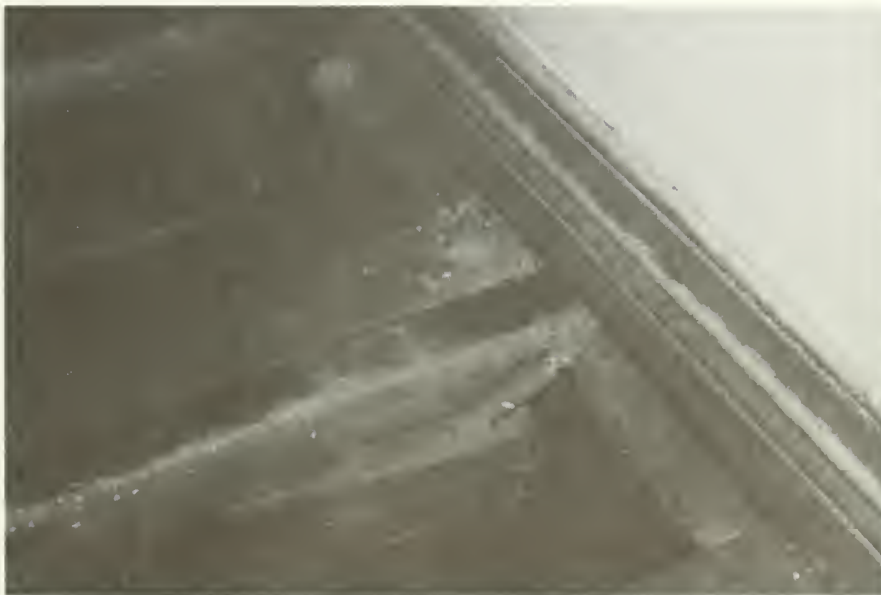
27. Room 105: east wing kitchen. West end of existing floor summer beam pocketed into hearth, December 13, 1979.

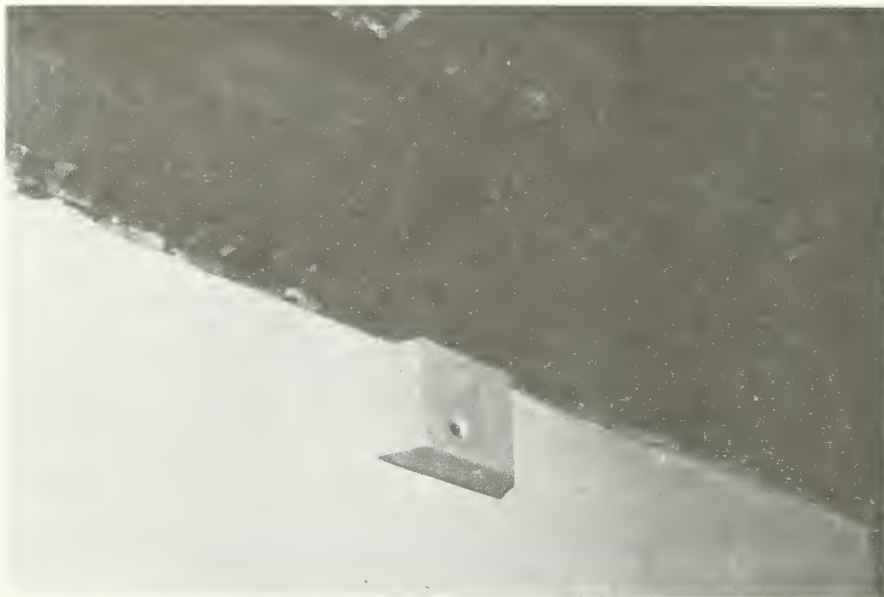
28. Room 105: east wing kitchen. East end of existing floor summer beam pocketed into stone wall, December 13, 1979.

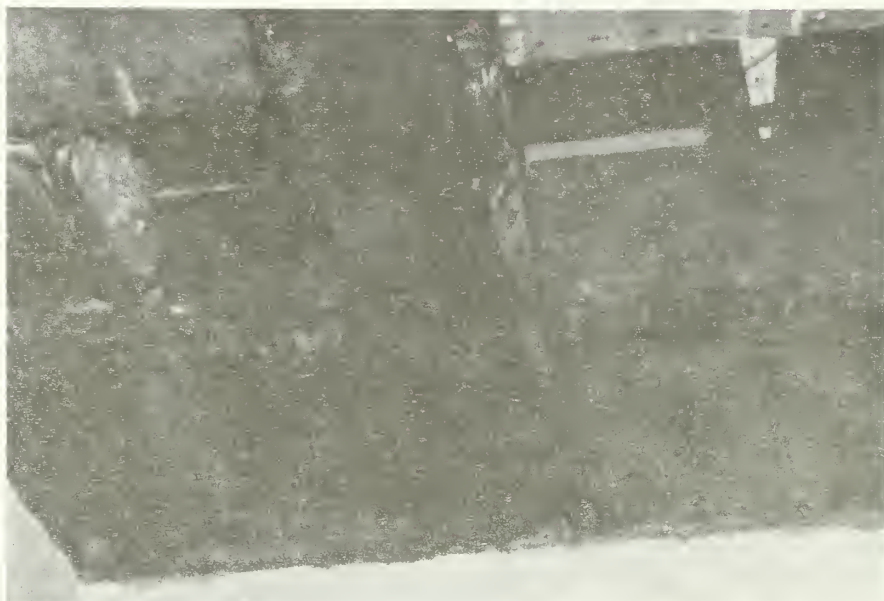
29. Room 105: east wing kitchen. View of existing ceiling summer beam pocketed into west wall above stove, December 13, 1979.

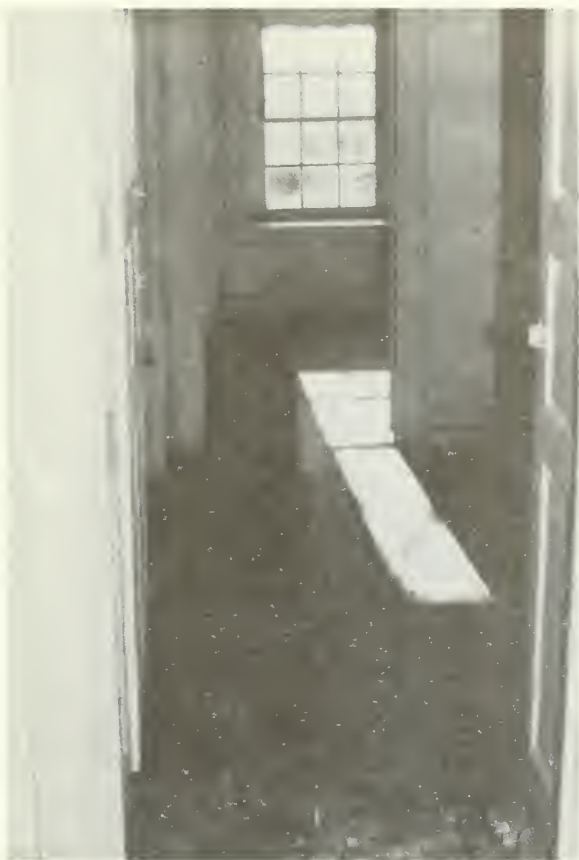
30. Room 105: East wing kitchen. View of existing ceiling summer beam pocketed into west wall, December 13, 1979.

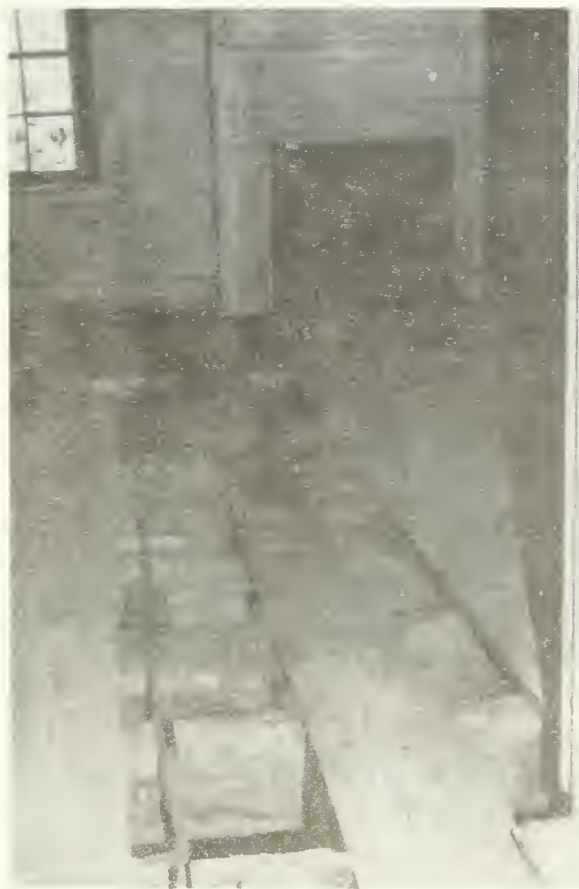
31. Rooms 203 and 201: second floor bedrooms. View south through Doorways 207 and 201. Flooring temporarily removed to expose existing summer beam, joists, and lead water pipe, December 13, 1979.

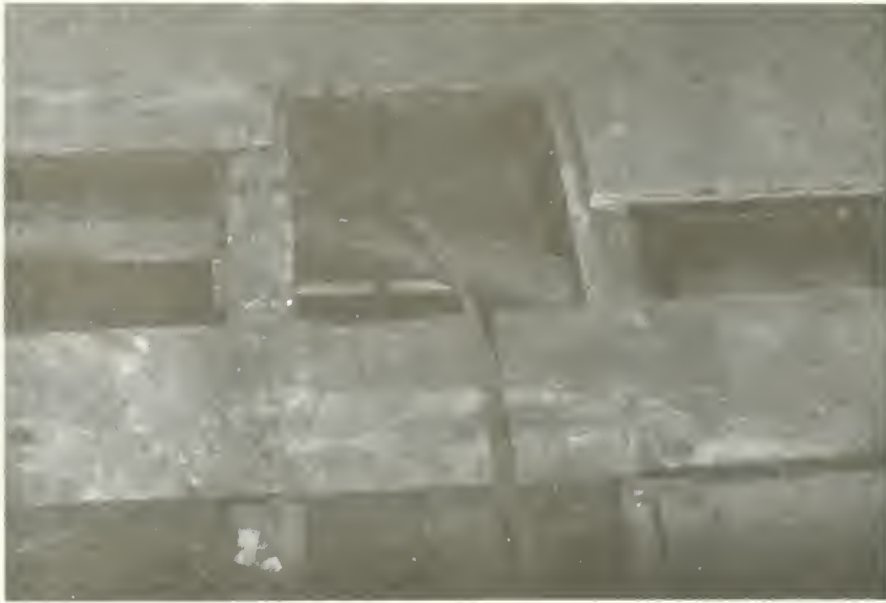
32. Room 205: second floor bedroom. View north through Doorway 209. Flooring temporarily removed to expose existing summer beam, joists, and lead water pipe, December 13, 1979.

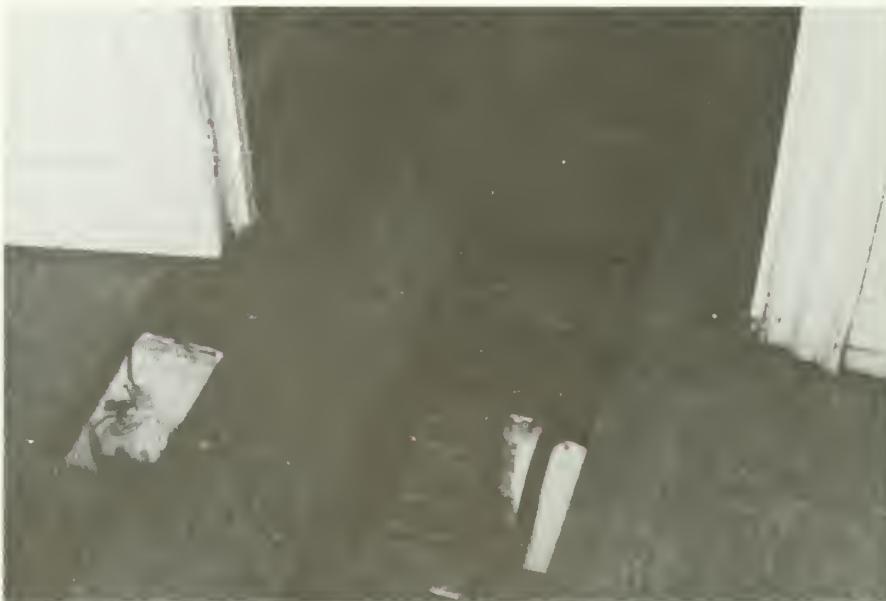
33. Room 205: second floor bedroom. Existing lead water pipe making turn through floor summer beam; changes direction from north to east towards Room 207, December 13, 1979.

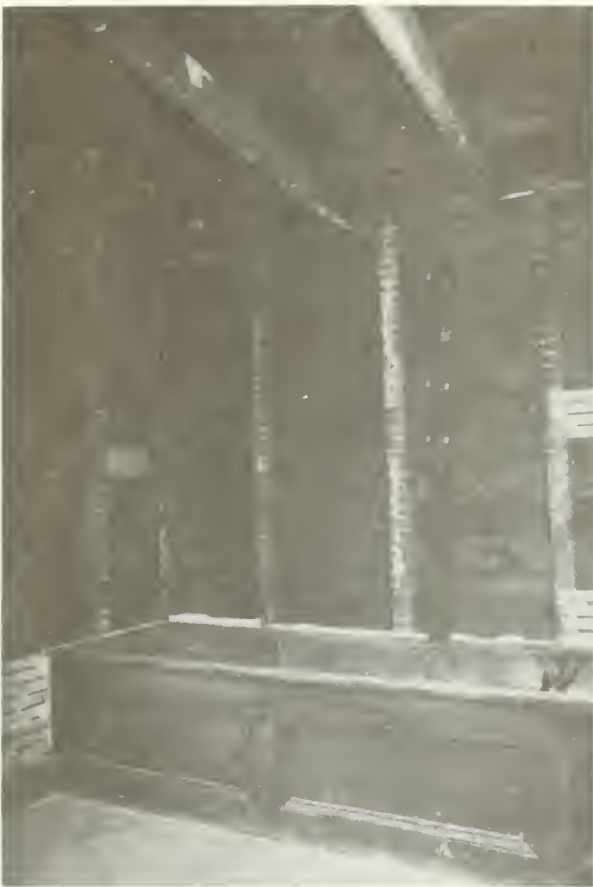
34. Room 205: second floor bedroom. Existing lead water pipe and floor summer beam passing through Doorway 209 from Room 204 (stairhall) into Room 205 (bedroom), December 13, 1979.

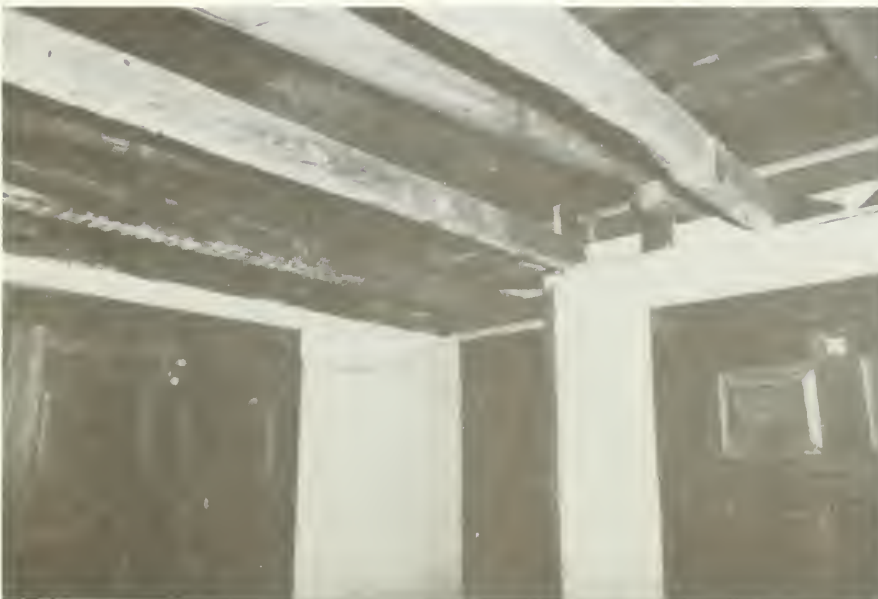
35. Room 207: Victorian bathroom. Historic lath and plaster removed to expose existing wall studs and ceiling/roof framing, December 13, 1979.

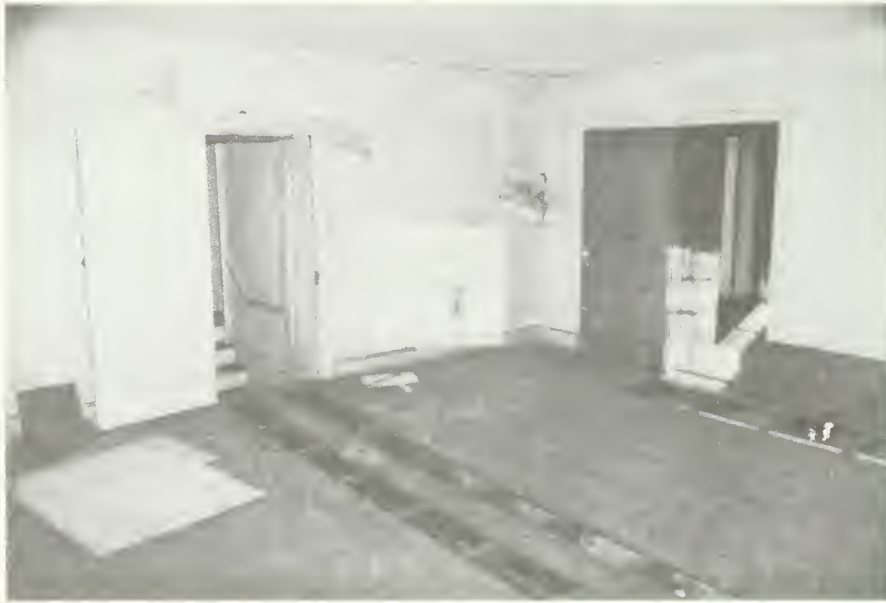
36. Room 207: Victorian bathroom. Existing ceiling/roof framing above Doorways (l-r) 214, 212, and 213, December 13, 1979.

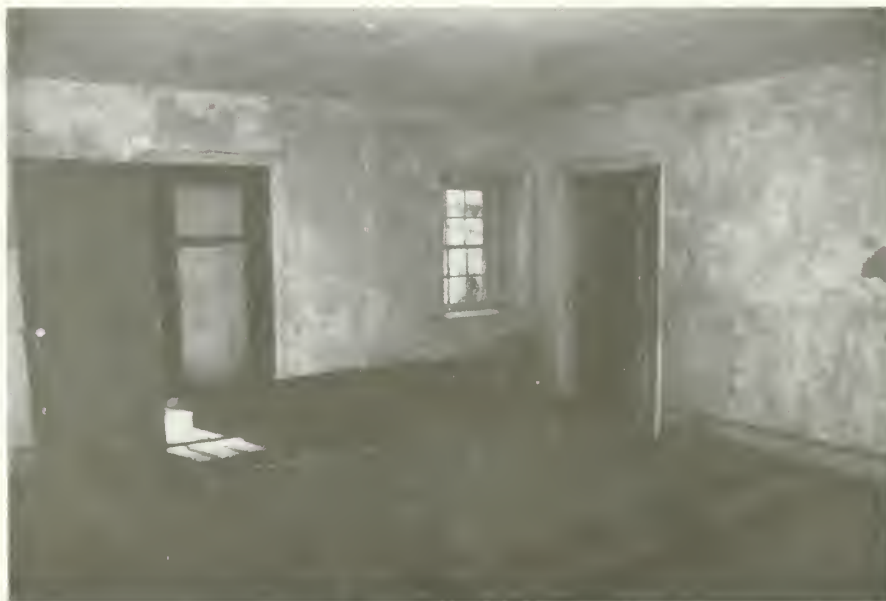
37. Room 207: east wing bedroom. Existing floor summer beam, joists, and lead water pipe exposed for record and inspection. View towards Doorways (l-r) 216 and 215 and northwest corner showing ghost lines in wall plaster of pre-1826 shed roof on the east wing, December 13, 1979.

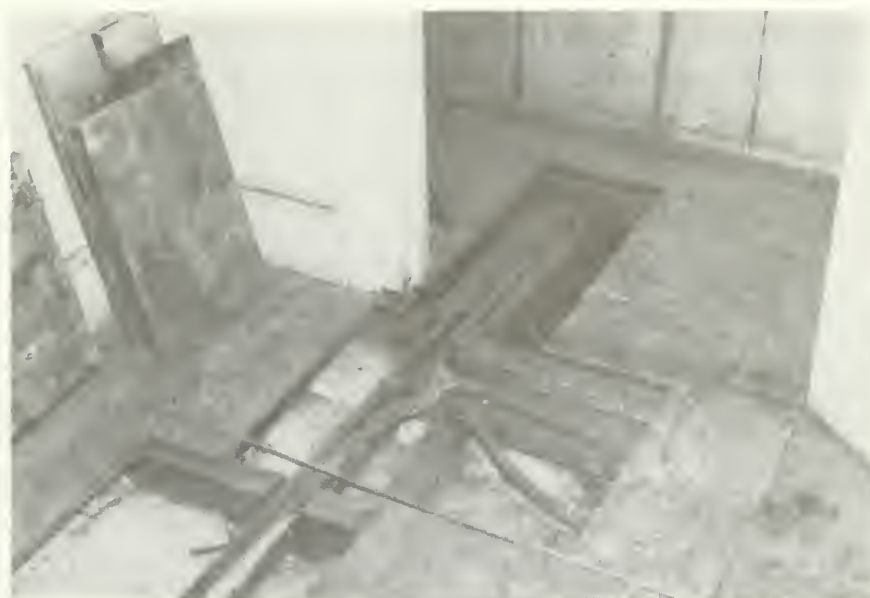
38. Room 207: east wing bedroom. Existing floor summer beam, joists, and lead water pipe exposed. View towards the northeast corner between Doorways (l-r) 215 and 217 and Window 213, December 13, 1979.

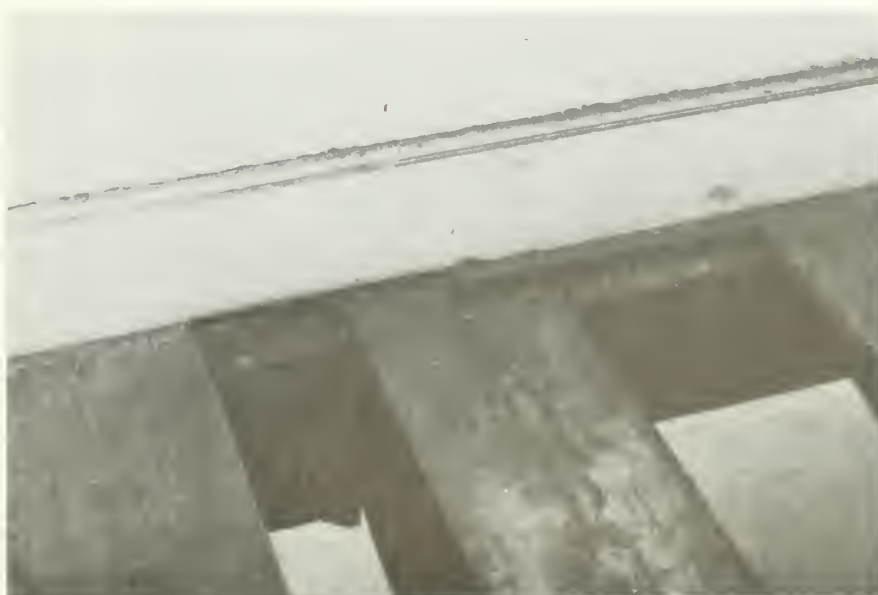
39. Room 207: east wing bedroom. Existing lead water pipes (circa 1870?), connections and downflow at closet and Doorway 217, December 13, 1979.

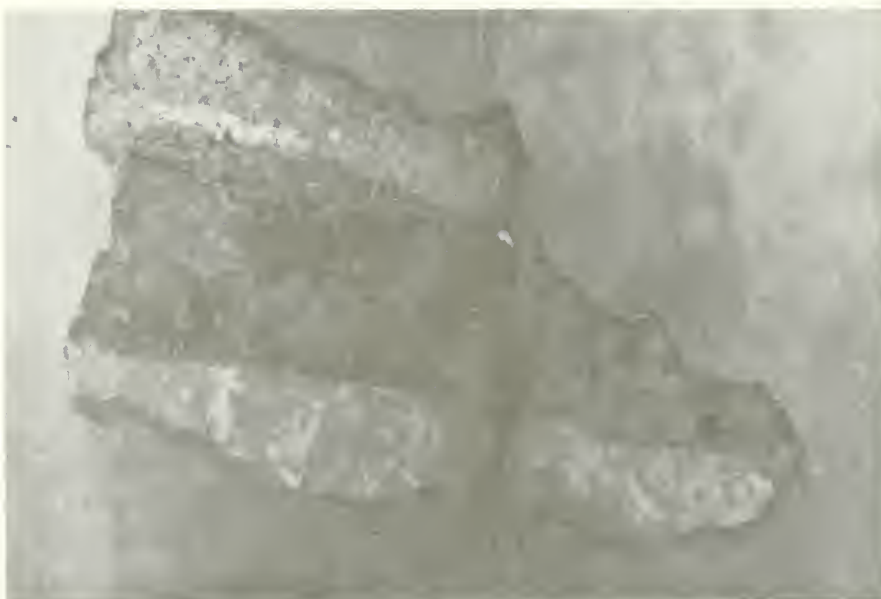
40. Room 207: east wing bedroom. Existing floor summer beam pocketed into east wall. Joists mortised and pegged into summer beam, December 13, 1979.

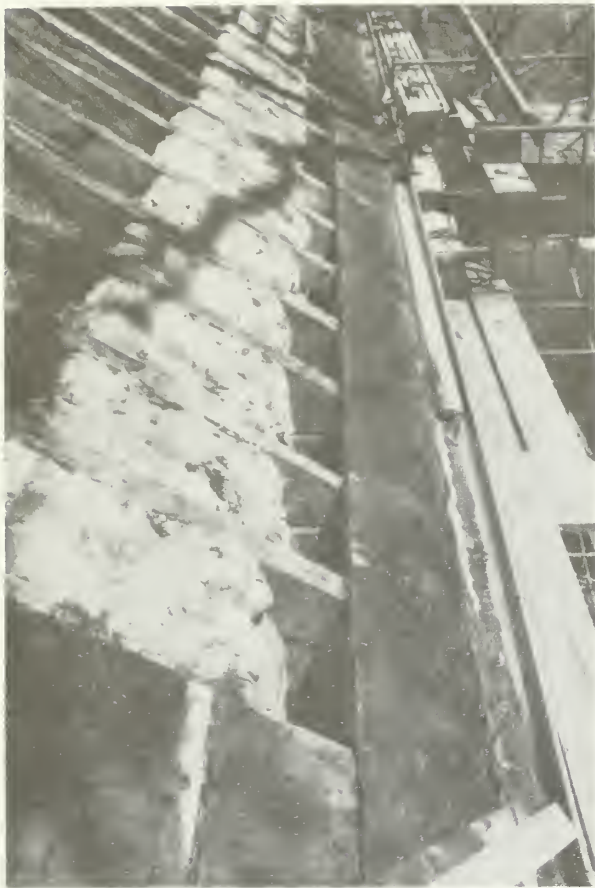
50. East wing roof. Existing rafters, nailers, and starter board at eaves of south slope, April 1980.

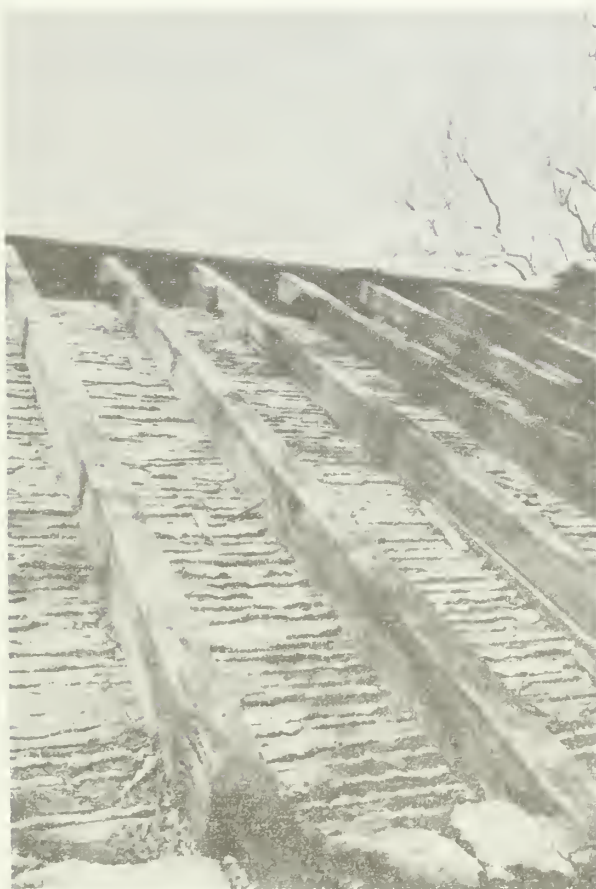
51. East wing roof. View along south slope showing existing rafters passing through stone wall into eaves and outrigger of joists. Existing lumber in place as shingle lath (nailer) starter board and as sheathing where east and west wing roofs join, April 1980.
